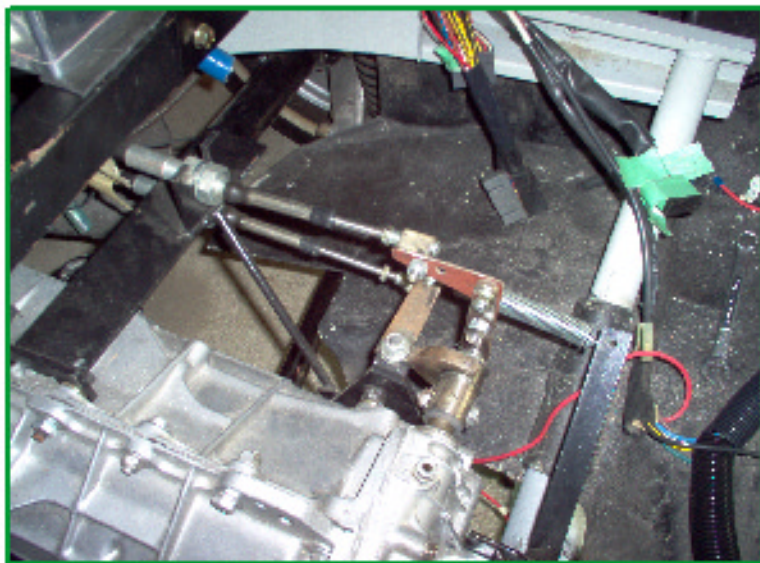
I used the John Pels cable shifter kit. This avoids the hassle of redesigning the solid linkage, and should contribute to more a precise and direct feel.

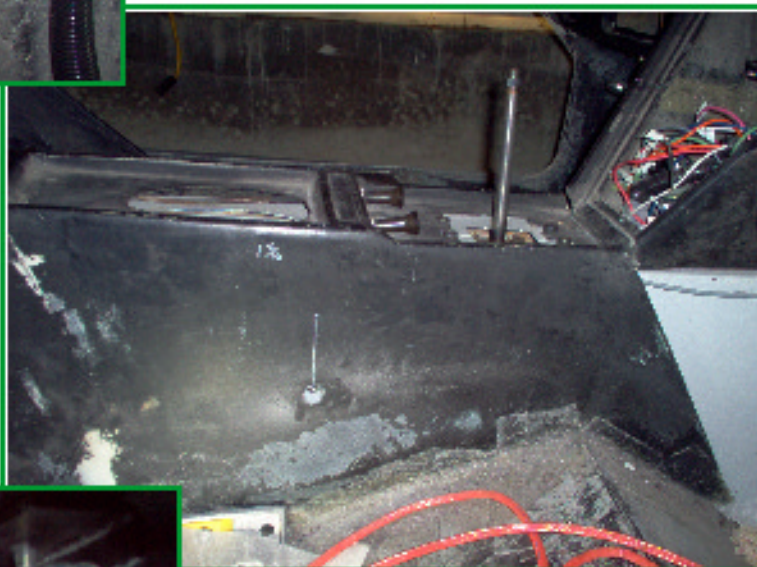
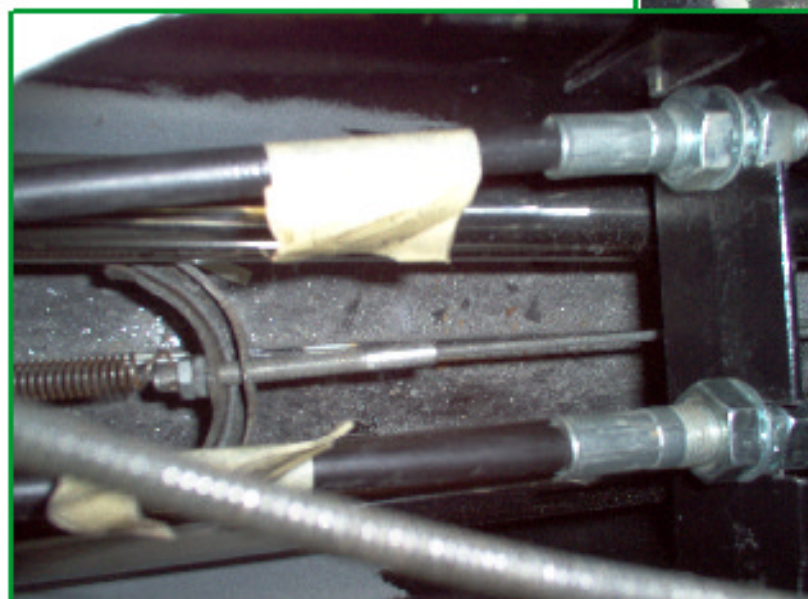
Measuring for the location of the cable mount in the backbone.

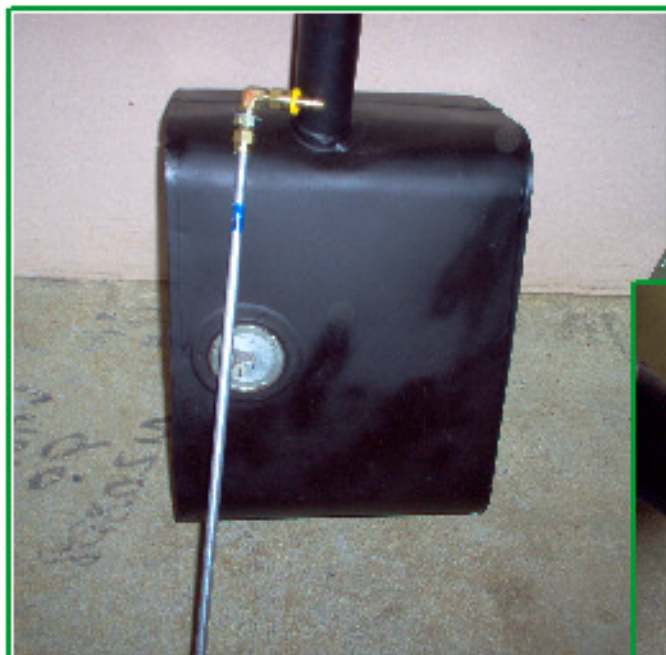
The 1/4" output line from the original gas tank will not be enough to support a fuel injection system. I built a 3/8" line, and installed it on the top of the tank. The original return line will still be used.

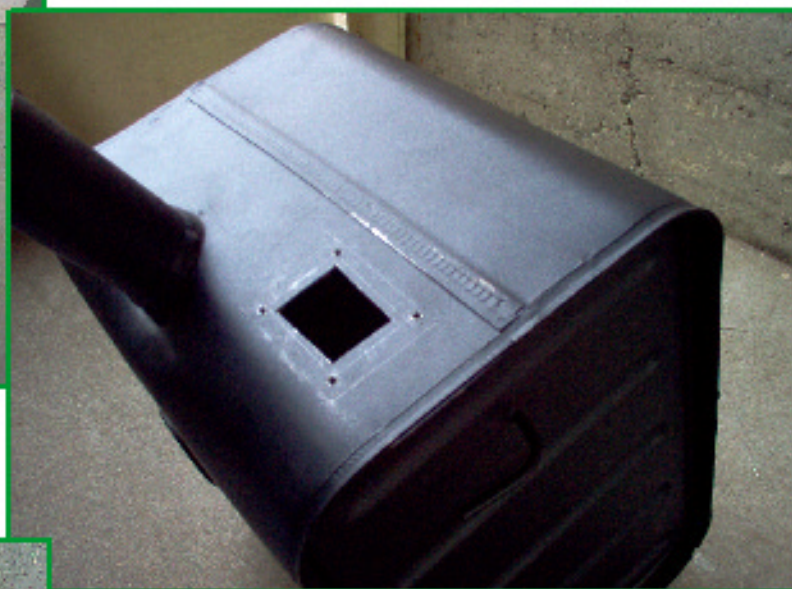
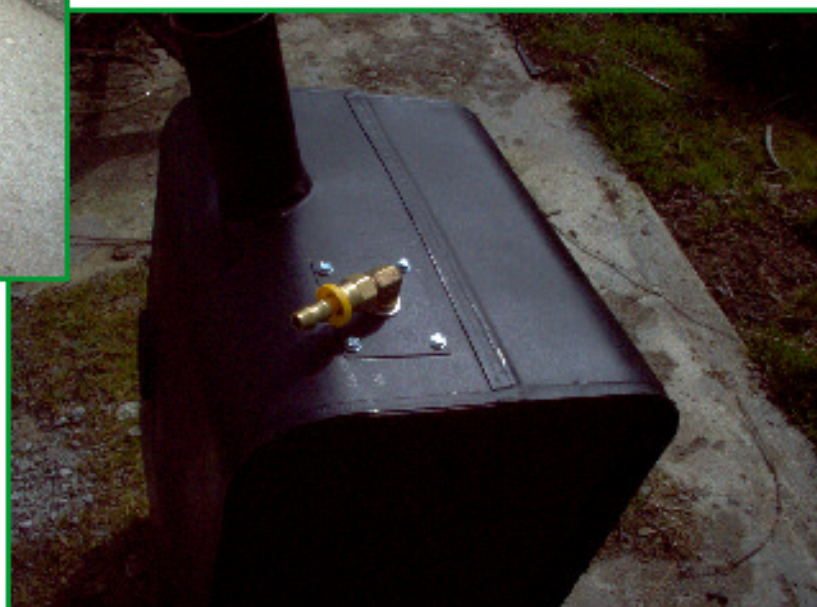
The new fuel pump will be installed below the level of the bottom of the tank, in order to prevent fuel from draining back inside.

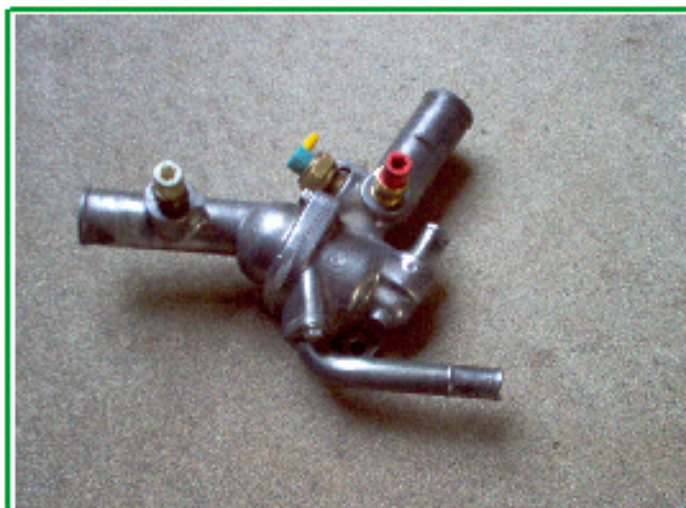
Toyota thermostat housing.

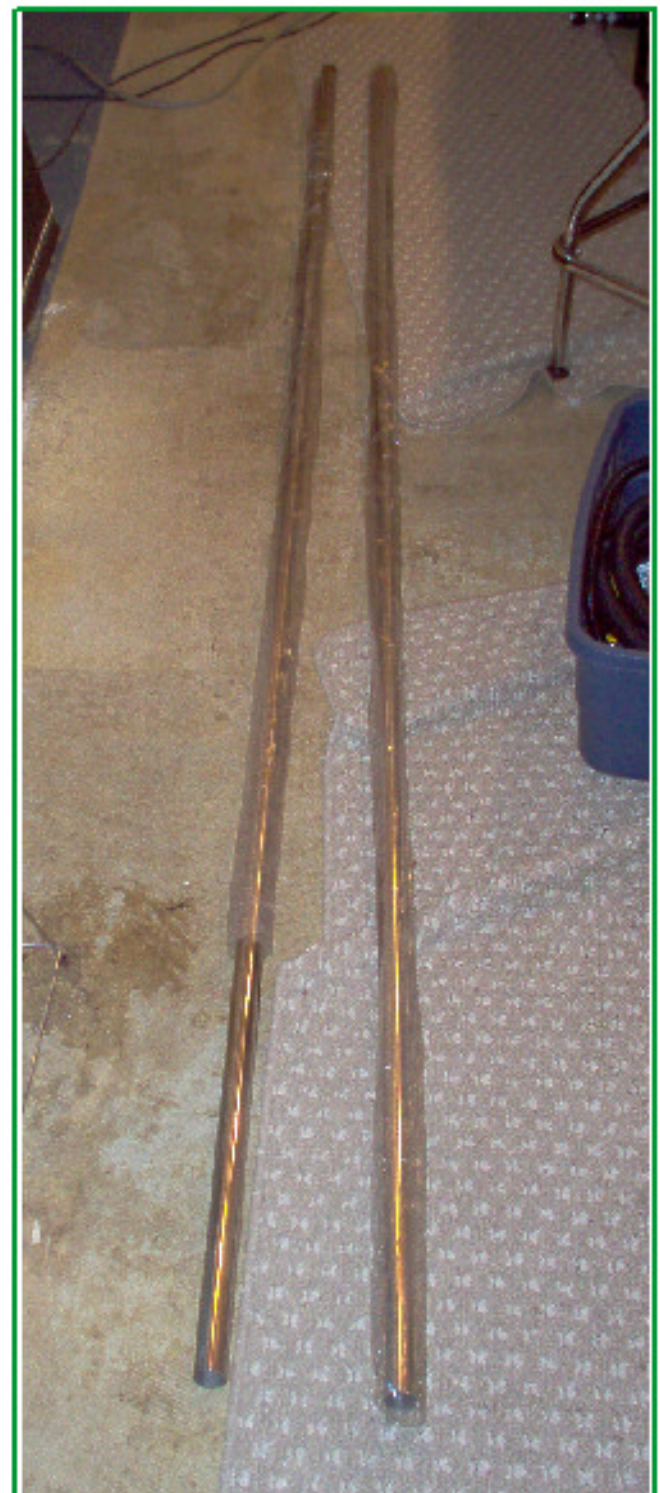
Stainless steel coolant tubes.

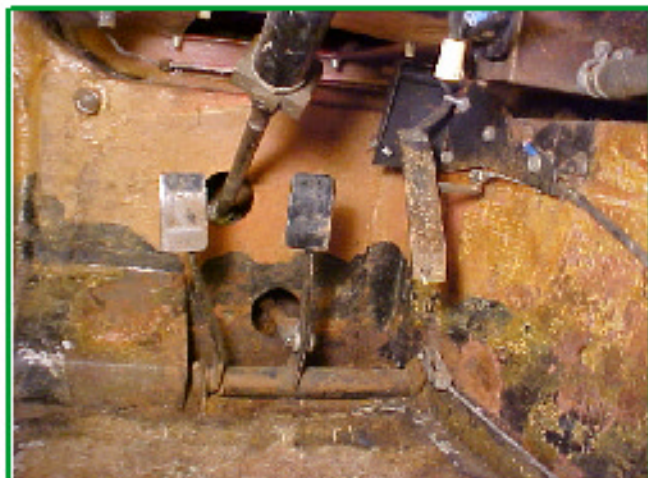
The original pedals were extremely rusty and corroded.

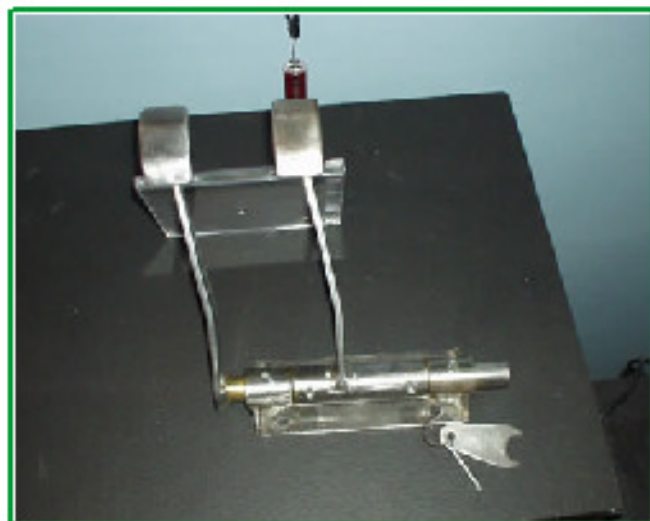
The initial design was close, but incomplete, and needed further refinements.

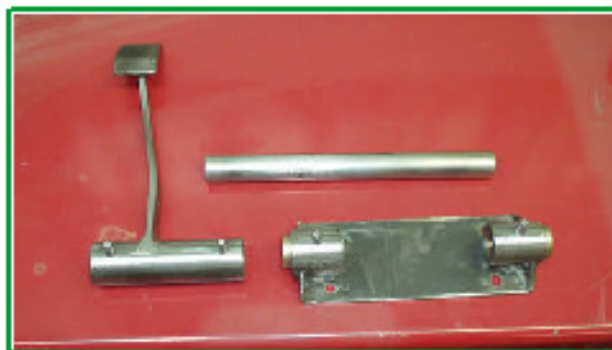
An entirely new pedal assembly was created. The new center shaft is stainless steel, wrapped in oilite bushings. Also note the new grease nipples.

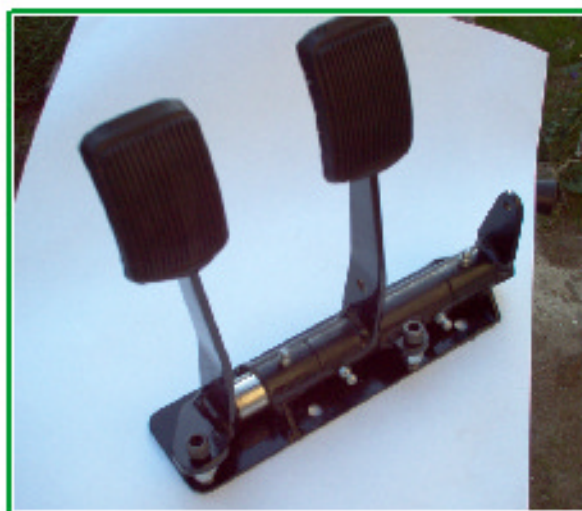
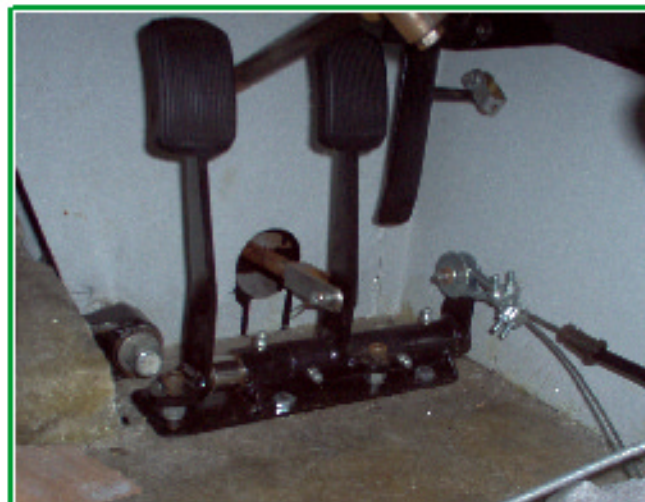
In order to prevent the pedals from falling back into the car, tabs were welded to the base of each pedal, then drilled and tapped for allen bolts.

The completed pedal assembly, painted, and mounted in the car.

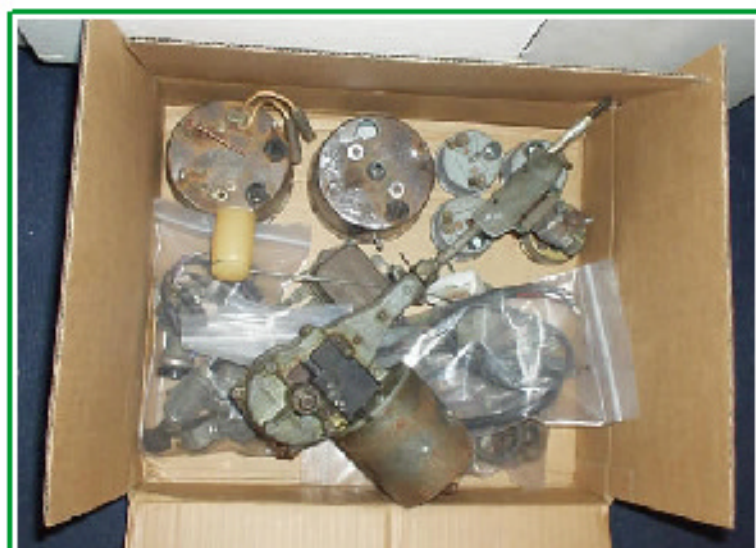
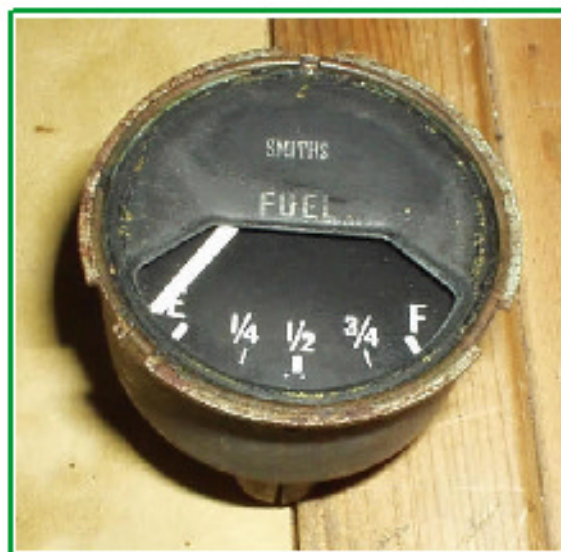
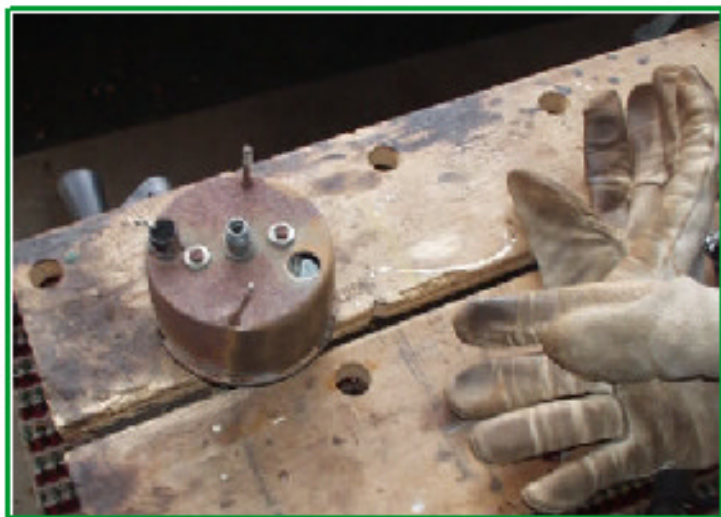
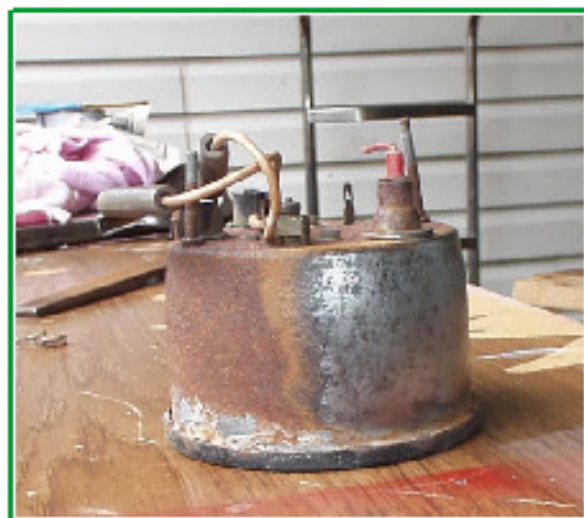
The gauges were in very bad condition. The cases were rusty, and the lettering on the faces had faded into unreadability.

The gauge cases, rings, and glass covers have been cleaned, and it's time to restore the faces.

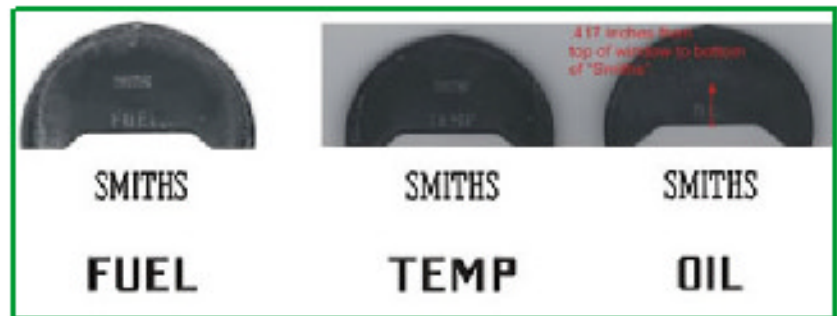
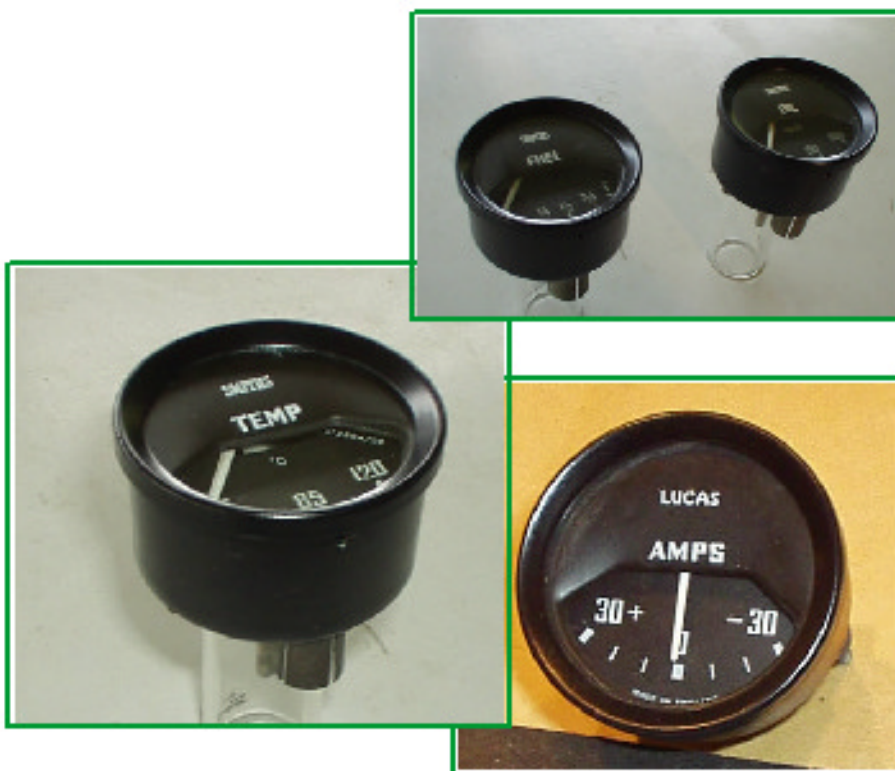
The gauges were a major project. The upper gauge faces were seriously faded, with very little color or definition left in the lettering.

With the help of Marty Shepard, I did a high resolution scan of the faces. We traced the lettering using vector lines, this allowed infinite size changes without degradation.

The faces were stripped, and repainted black using PlasticKote Super Enamel. We then applied a frisket film, and using the vector file, laser-cut the new lettering into the frisket. Finally, the faces were painted white using two light coats of white Tamiya model paint. After the frisket was peeled off, and the cases cleaned and painted with POR15, the gauges were reassembled.

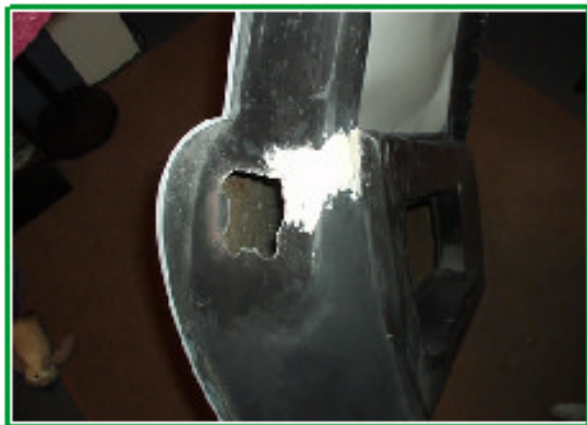
The doors had a few stress fractures, which were easily repaired.

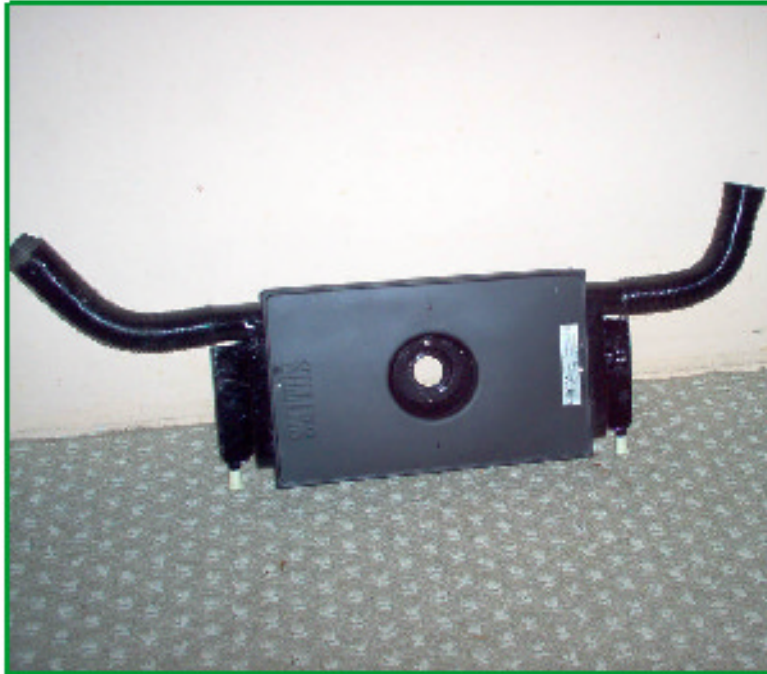
The heater core was re-cored and the case cleaned and painted. The restored steel vents are installed, and the hoses attached.

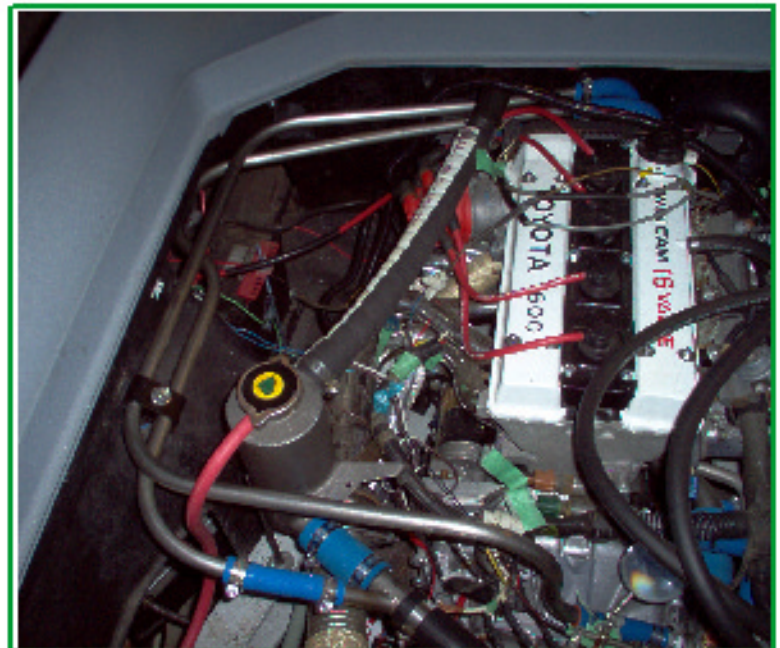
The swirl pot is from a TC, and is in much better condition than the original. The new pot has been treated with phosphoric acid, and is lined with a tank sealer from POR15.

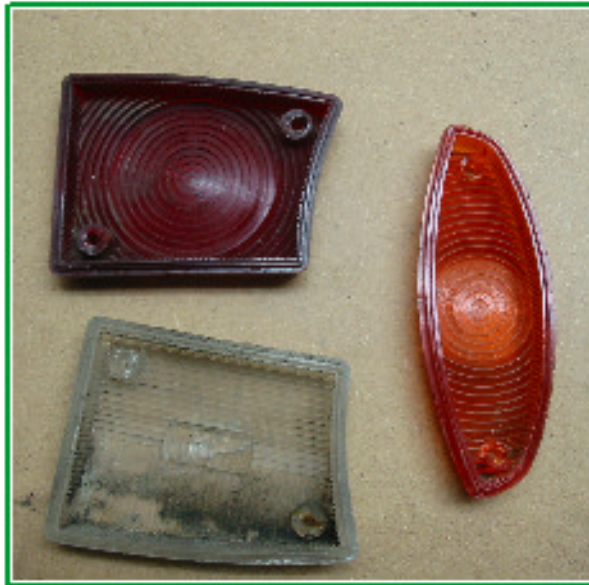
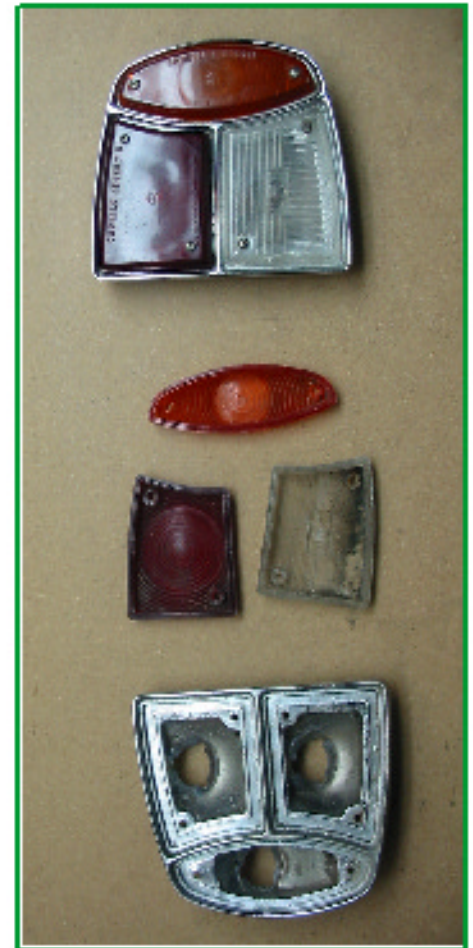
These tail lights are unique to the S1 Europa They are sourced from the Lancia Flavia coupe, and are quite rare. The lenses have been removed and polished, the sockets treated with phosphoric acid, and the chrome cases restored.

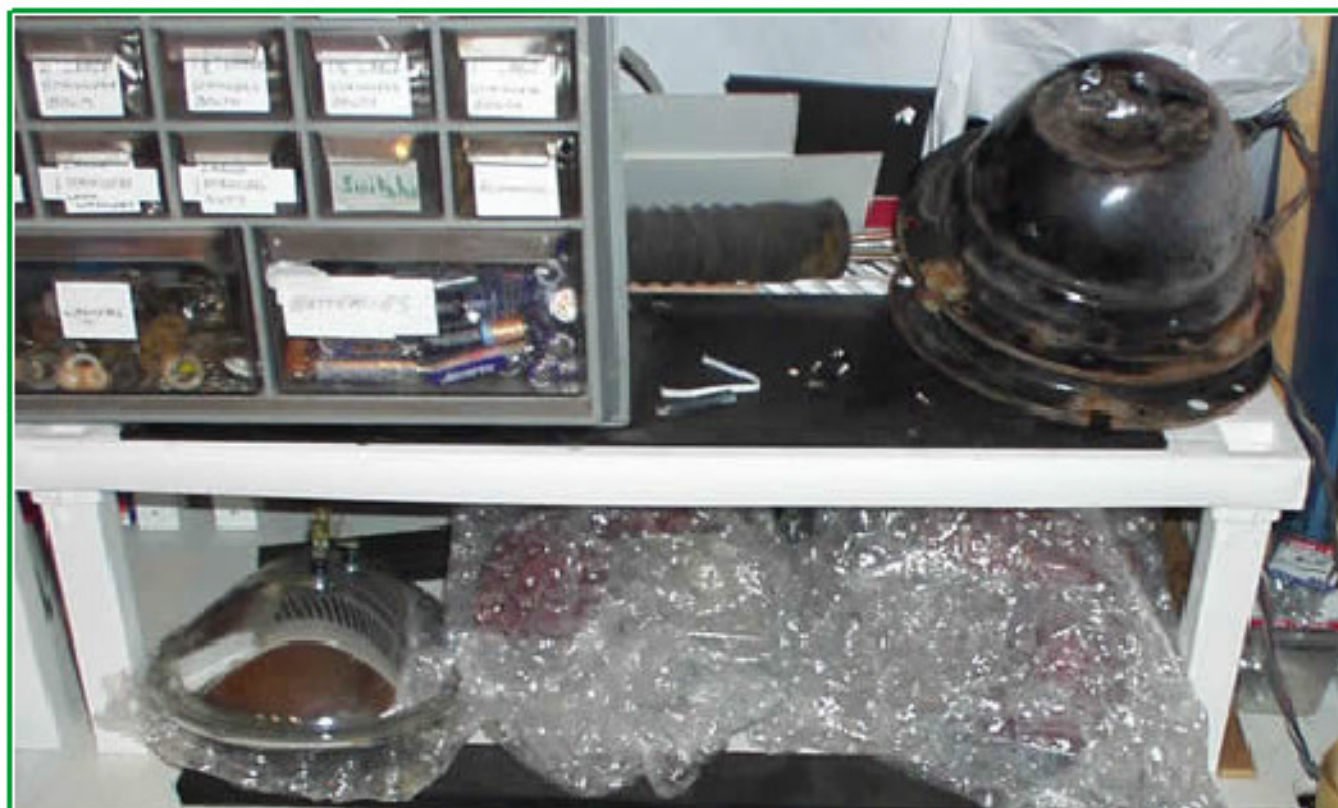
The headlight buckets needed cleaning and paint.

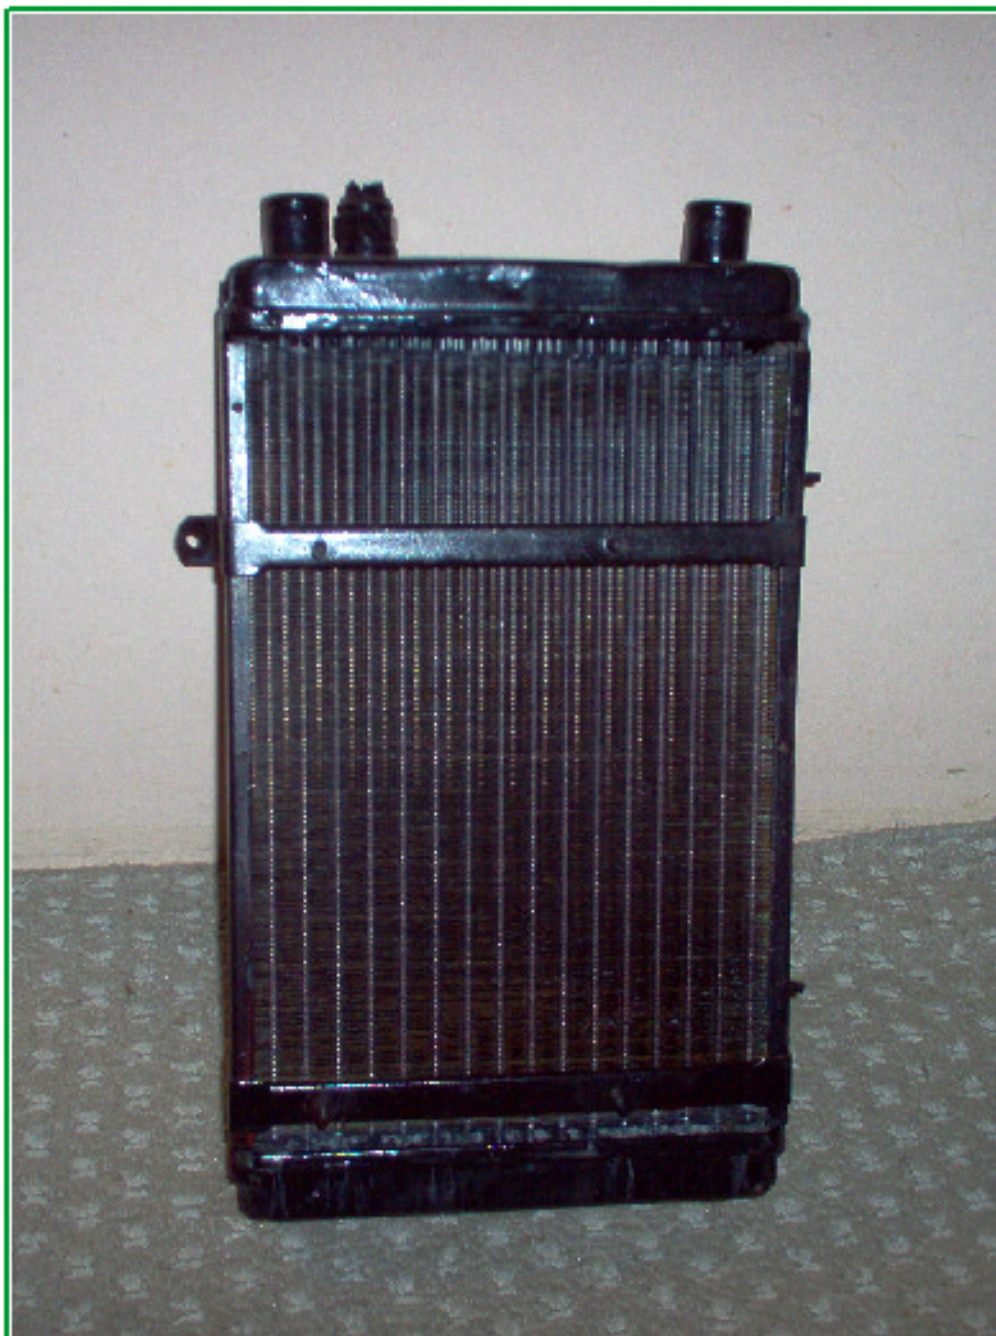
The radiator, cleaned, re-cored, and painted.

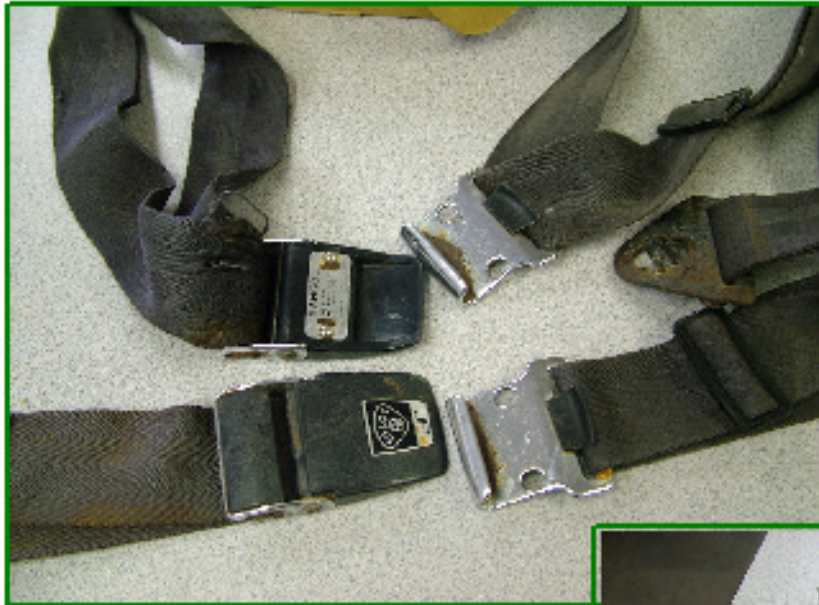
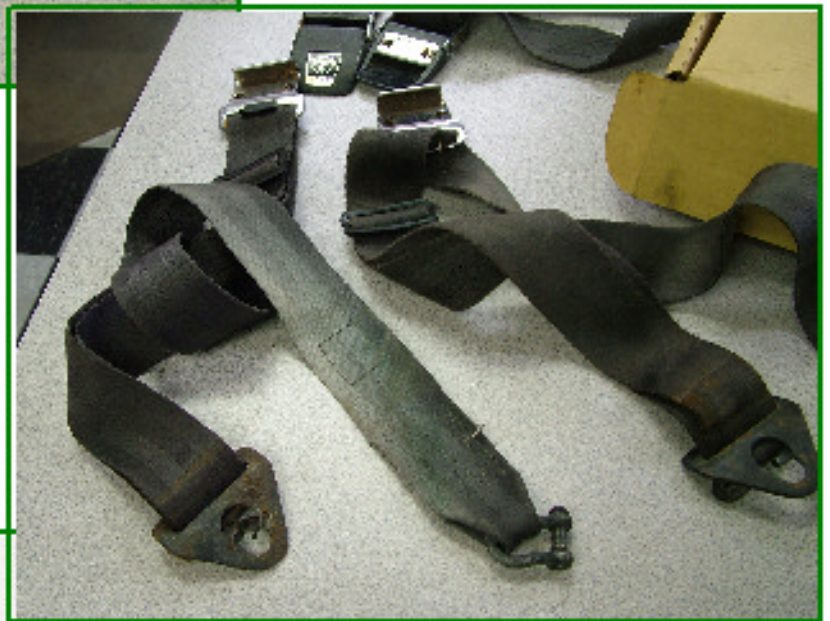
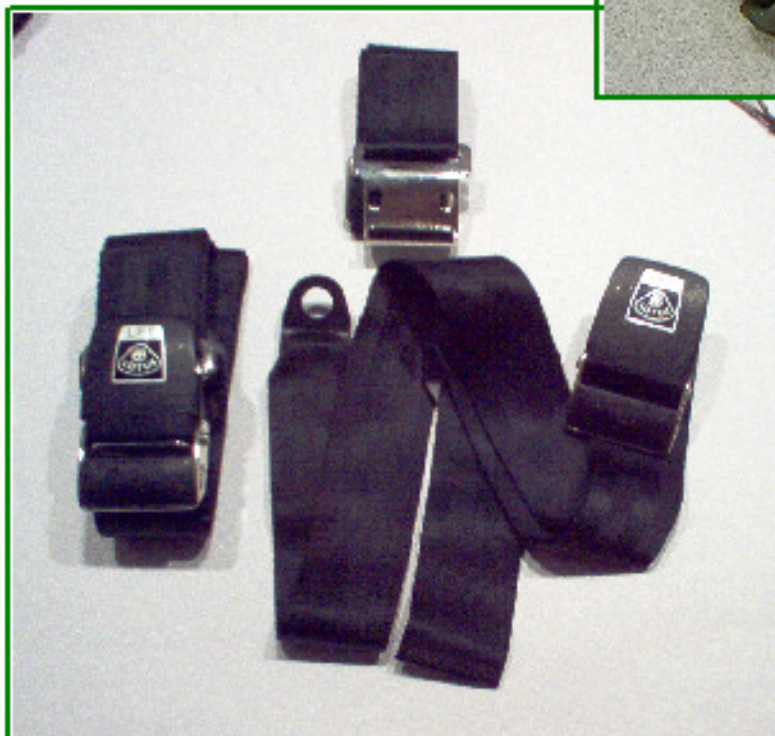
The seatbelts needed a complete rebuild, which was carried out by a specialty shop in Kelowna.

Restored seatbelts.

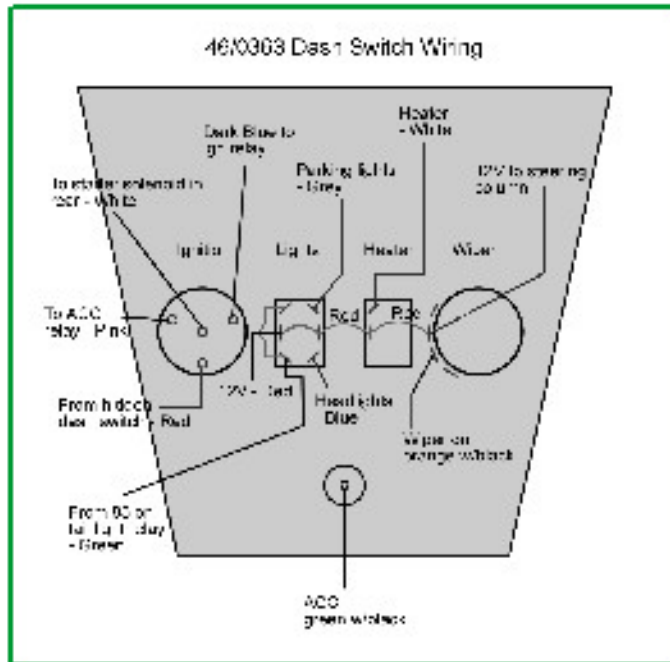
All the new wiring required detailed diagrams.

The elusive Toyota circuit opening relay.

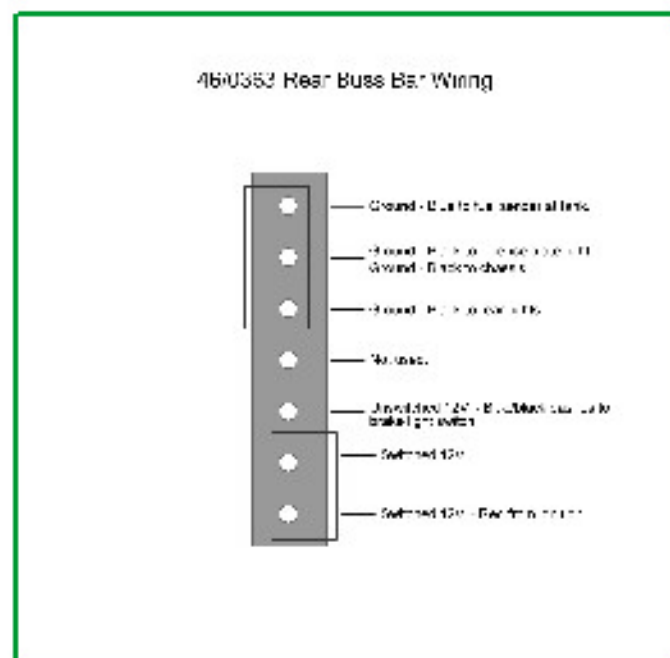
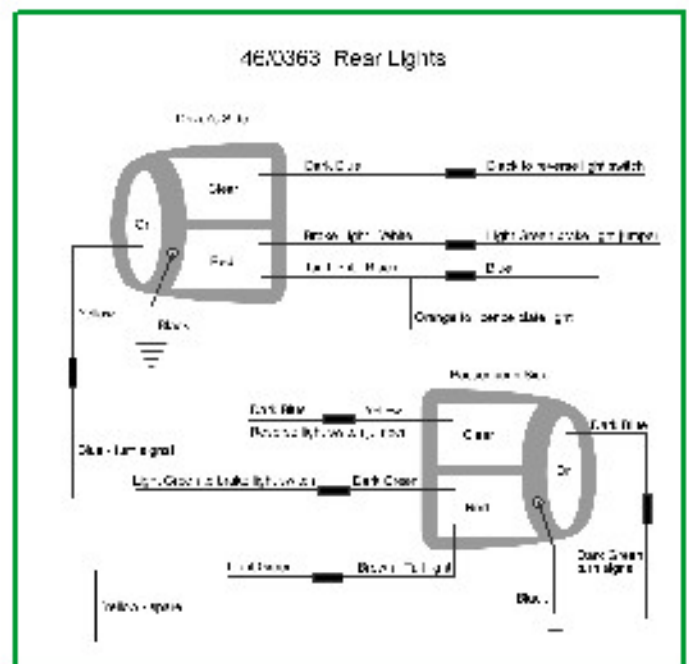
More examples of the new wiring diagrams.

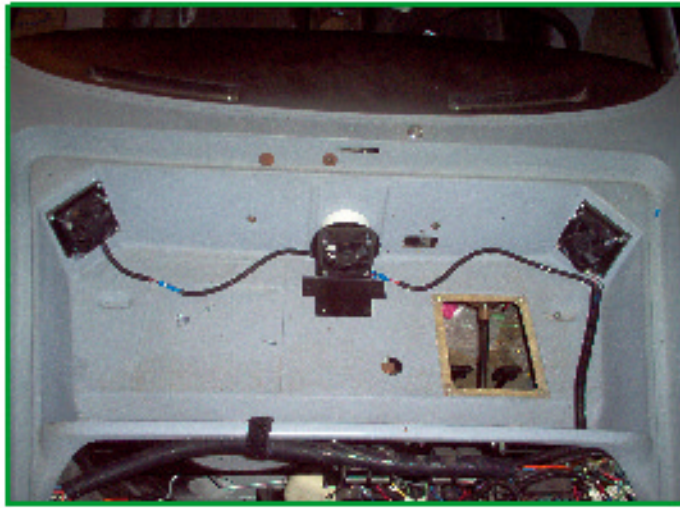
12v fans force air into the cabin through the vents and heater core.
