00EN079

Date: 1975

TWINCAM VALVE STEM SEALS

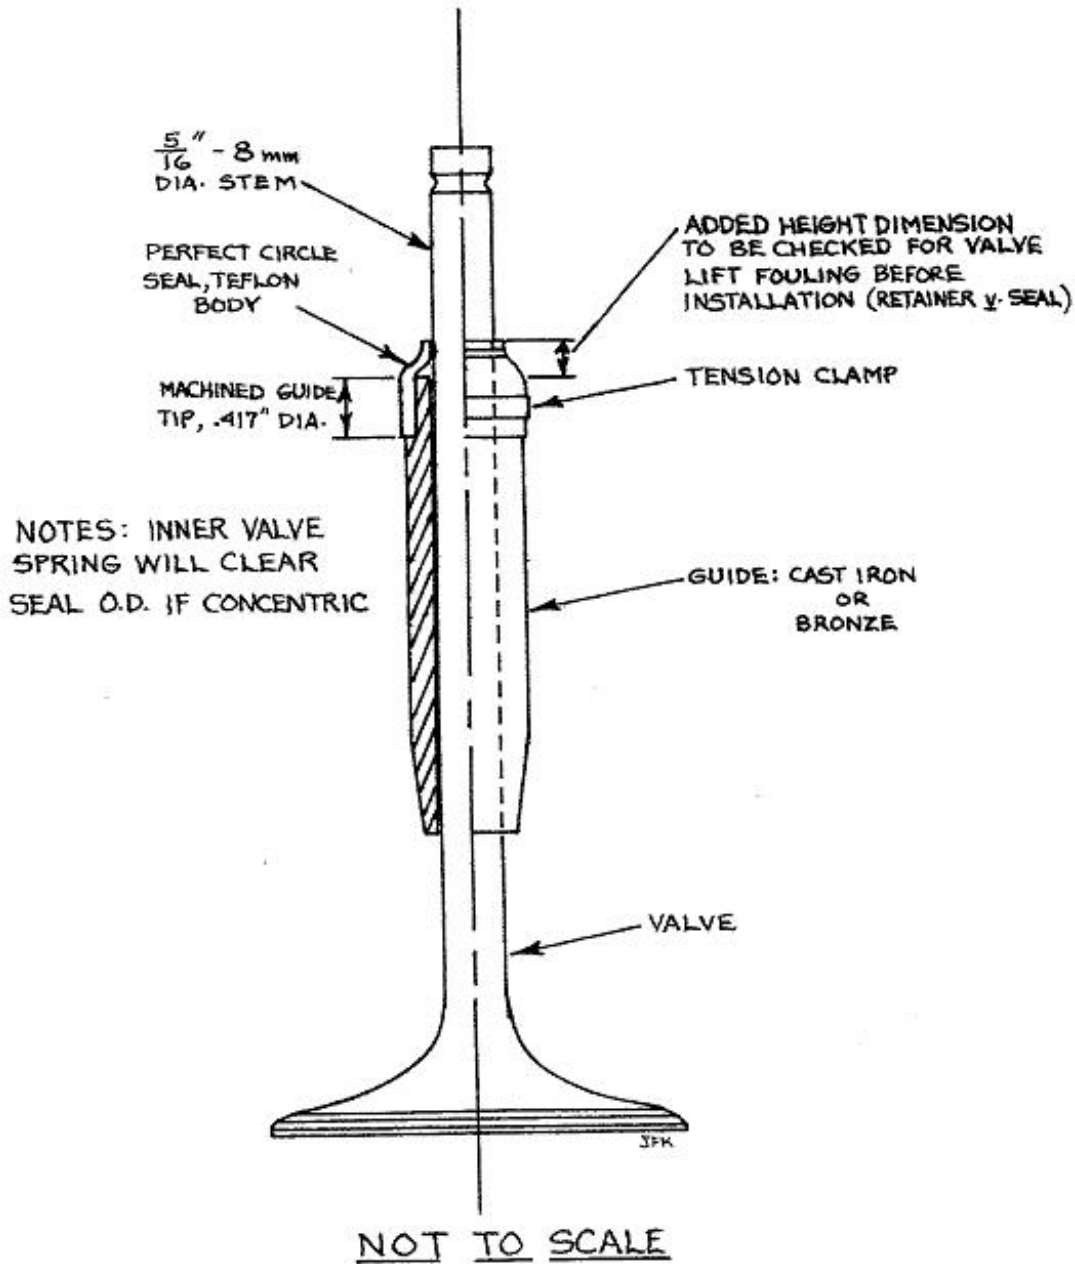
To install, major work is necessary, including machine shop time. The old guides must come out and most likely will be ruined. Bronze or cast iron standard ENFO guides must be machined from 0.500" OD to 0.417" to a depth suitable to accept the body of the seal and its metal spring clamp. The guides are then installed without seals, seats reground, and, finally, seals pressed on from the top. These seals have been used with cam lift of up to 0.400". At this lift, retainer to seal clearance gets very small, however.

Several seals are available to fit modified Twincam guides. The part discussed in this article is the Perfect Circle all-teflon seal which will accept 7/16" or 8 mm stems. The part number is VS-17-18 (#9010) as used on GMC diesels. Special order through distributors is necessary. A set runs about \$10 - \$15. Apparently specialty "head" shops discovered this seal too as it has been obtained by specifying Pinto 2000 OEM seals. The latter appear to be the same seal with less clamp pressure and are, therefore, easier to press onto the modified guides.
