Lotus Service Bulletin

CLASS: 111
NUMBER: 1973/20
TYPE: Europa TC & Special
Date: 10.08.73

Title: Facia Crash Pad.

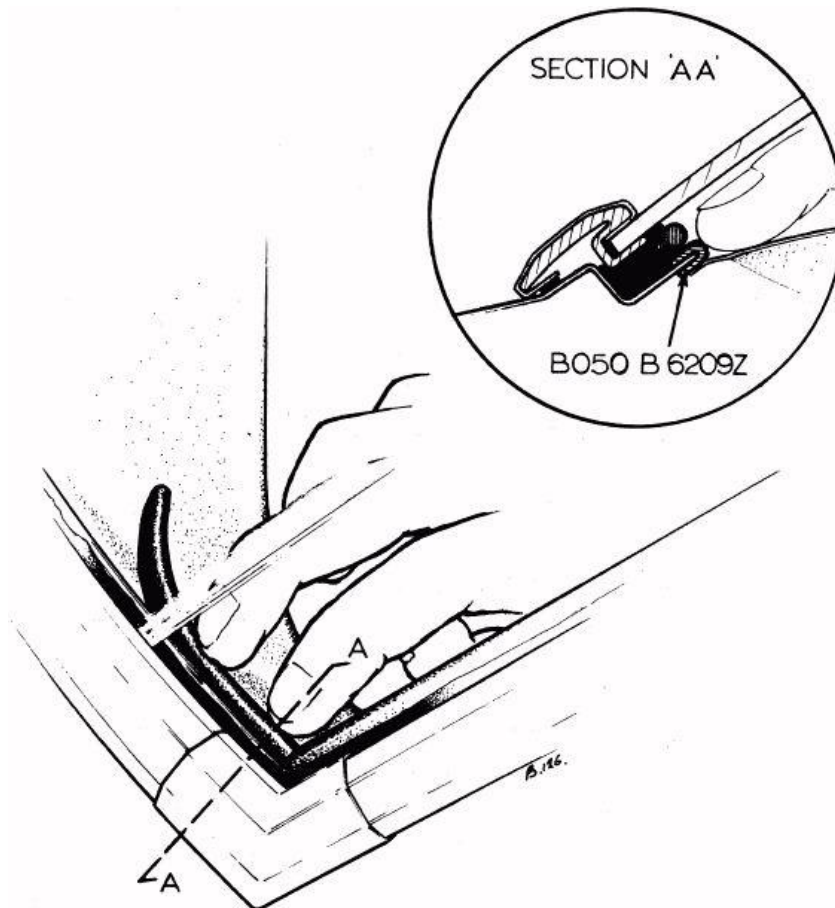
Reason: To recommend an approved Service fix to retain extreme forward ends of crash pad trim, BUT ONLY in the event of peeling.

1. Turn back the lifted edge of the trim, and remove all traces of old adhesive.
2. Using a suitable adhesive (see Section 'B' of Workshop Manual), secure the trim in its original location, pushing as far forwards as possible. Remove surplus trim with a sharp knife.
3. Using the illustration as a guide, insert the pieces of windscreen internal trim at the extreme ends of the Lower internal windscreen flange, pushing fully into place with the fingers. The 'U' section of the pieces of trim, pass over the flange, thus securing the crash pad trim.
