NEWS FROM LOTUS / EAST

SERVICE BULLETIN #4

LOTUS EUROPA
Gearbox (Transmission)

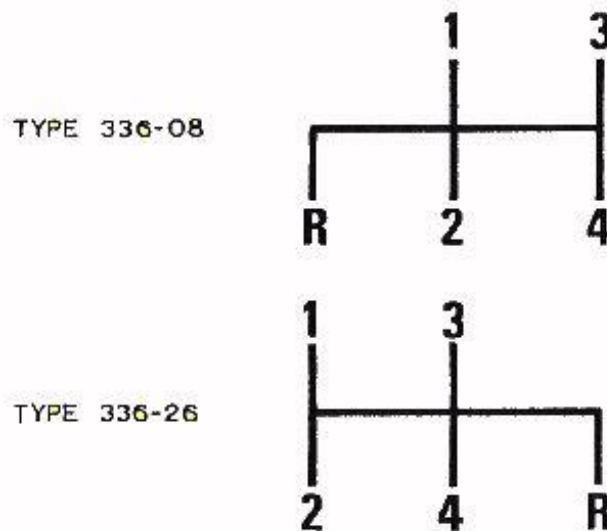
Commencing at Unit No. 46/0267, a new gearbox (Part # A46F723) with revised gate pattern has been fitted. The gate pattern refers to the gearshift lever.

If reference is made to the identification tag at the rear end of the gearbox, adjacent to the selector shaft, this will show which type is fitted (either 336/08 or 356/26), see below.
